RE: San Miguel Electric Coop, Inc.
San Miguel Mine, Permit No. 11G
Final Action Notification, NOV 118A

Statement of Inspector's Observations
Notice of Violation No. 118A
Issued to San Miguel Electrical Cooperative, Inc.
San Miguel Mine, Permit No. 11G

COAL MINE INSPECTION REPORT

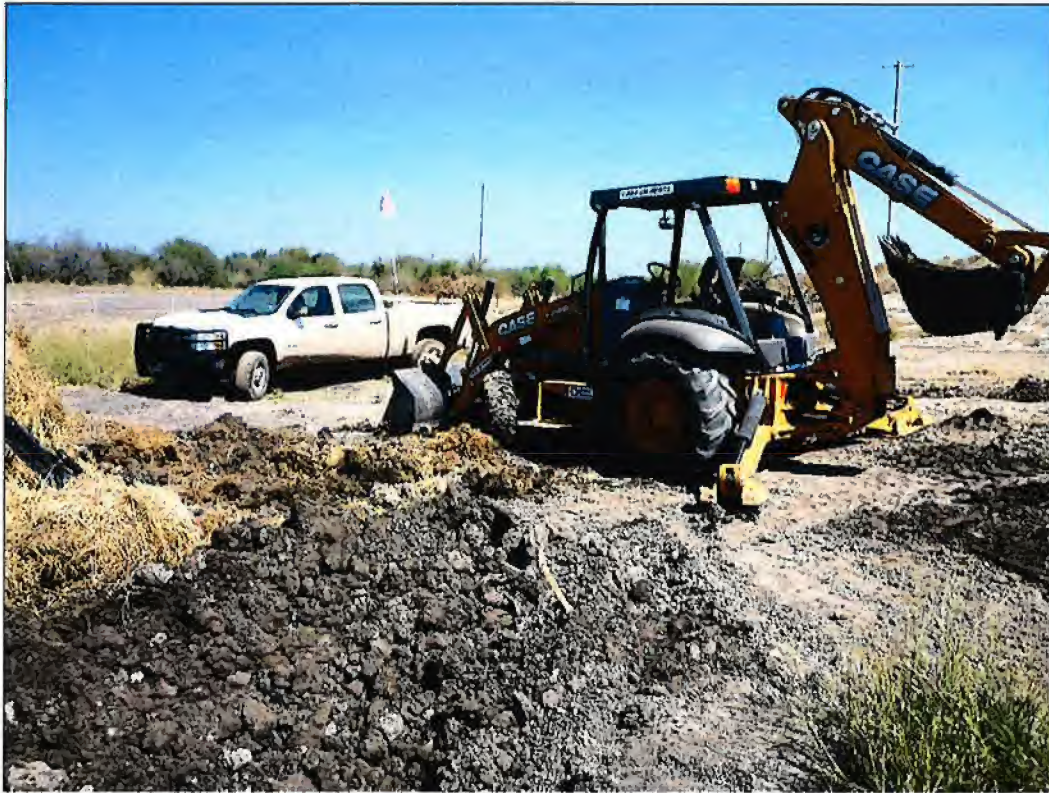
Photo 1. Backhoe staged at the BN-2 Drop Structure in October (view north).

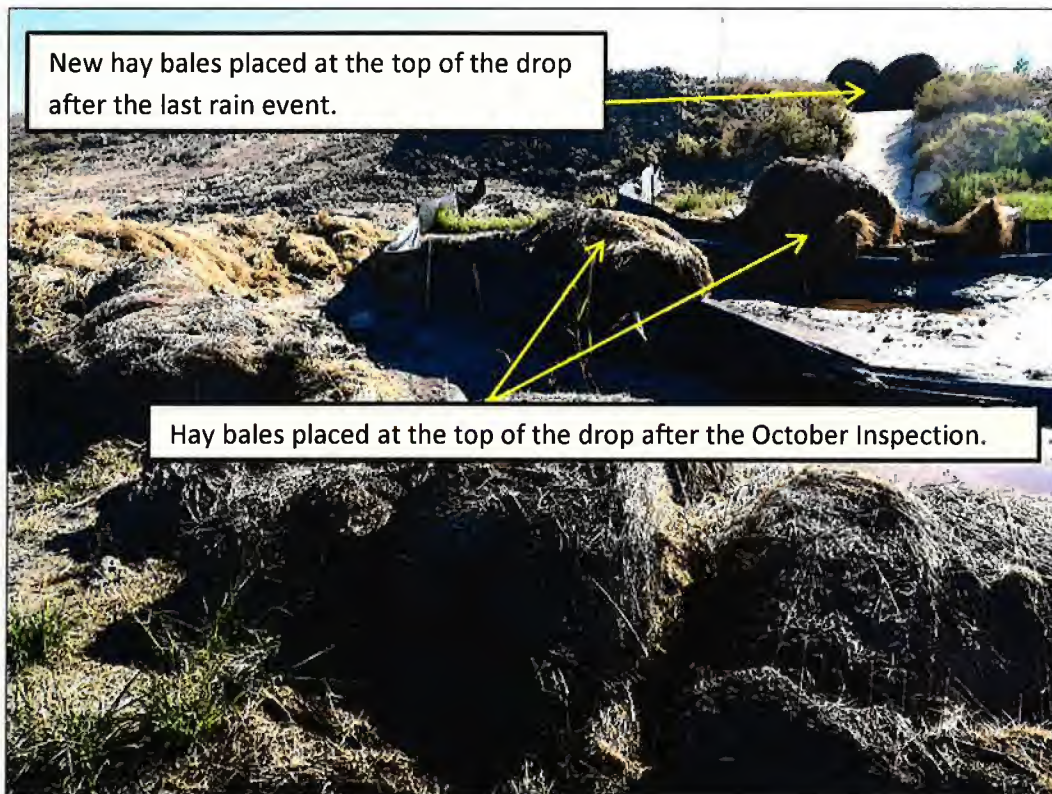
Photo 2. Hay bale failure (view east).

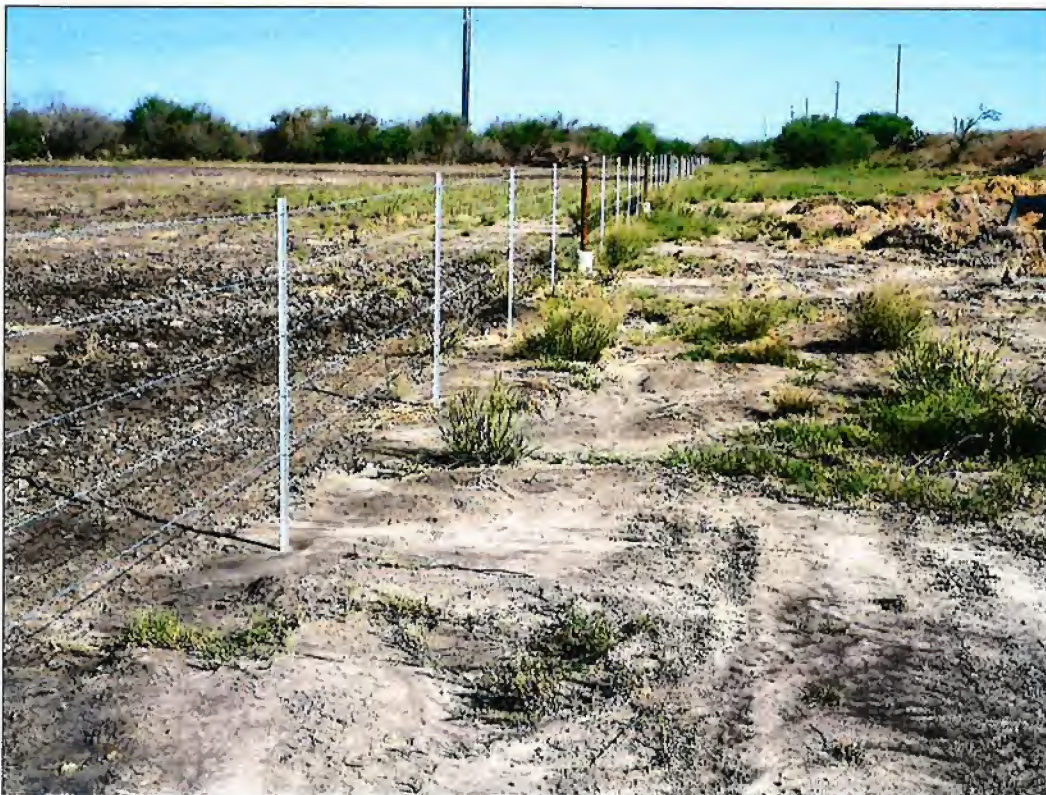
Photo 3. Permit Boundary (fence line) with no sediment control measures (view north).

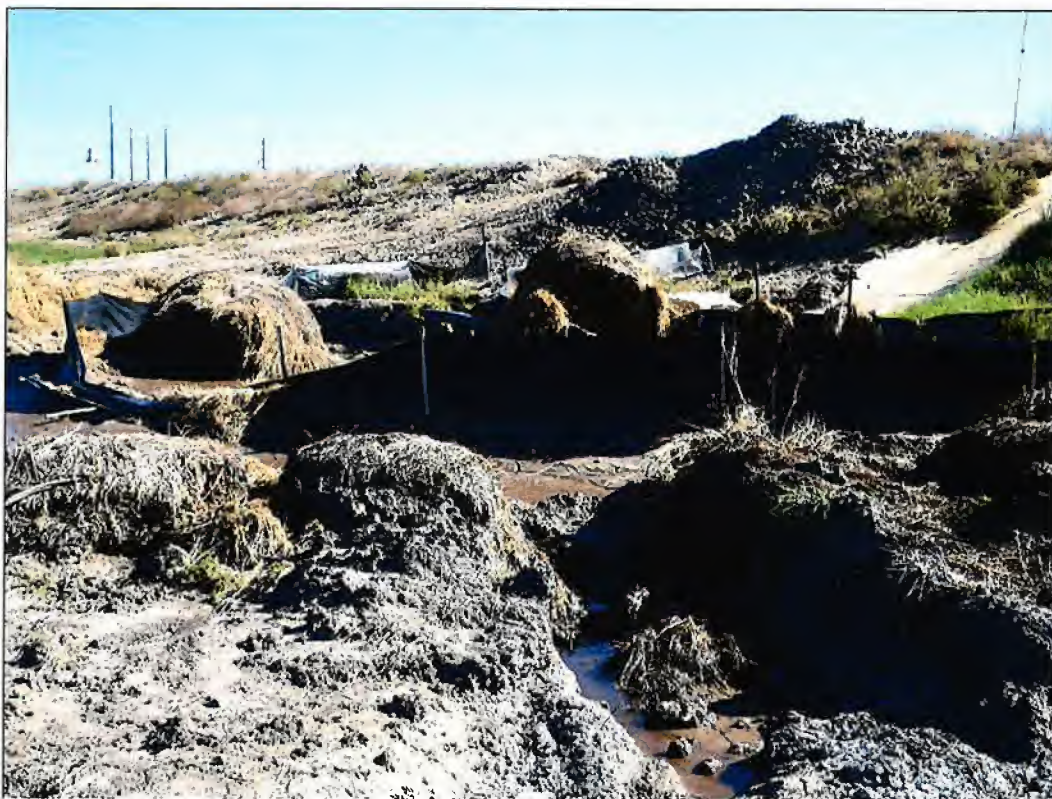
On November 18, 2015, SMRD Inspector Barry Gibbs and I inspected the BN-2 Drop Structure to observe if the sediment control measures implemented by SMECI were functioning properly. The BN-2 Drop Structure has been observed every month since SMRD Inspector, Jacob Eickstead, issued NOV 114A at this location in April 2015, for sediment leaving the permit area. During the following six months, Mr. Eickstead informed SMECI that immediate action is needed to ensure that sediment will not flow out of the permitted area and onto the adjacent property again. During my October inspection, SMECI representative David Burris and I traveled to the site for inspection. A backhoe was brought in (photo 1) on the second day of the inspection and attempted to remove sediment from the sump, but due to saturated soils, SMECI suspended the operation until the area dried out. I recommended to Mr. Burris that additional silt fence be installed around the sump location and along the permit boundary as extra protection. During the inspection on November 18, 2015, it appeared that two round bales of hay were added to the top of the drop structure (photo 2), the previously placed hay bales had washed down into the sump during the earlier rain events. Also, no additional silt fence was observed installed around the sump or along the permit boundary fence (photo 3). The hay bales that were installed earlier in the year around and below the sump, have silted up and have eroded, leaving large gaps between the bales allowing sediment to freely flow through and out of the permitted area (photo 4).

Upon review of the Regulations, Permit No. 11G and discussion with the I&E Manager, Notice of Violation 118A was issued to SMECI for failure to maintain appropriate sediment control measures at the sump below the BN-2 Drop Structure. This is a violation of Texas Coal mining Regulations Title 16, Texas Administrative Code §12.343 and section .154 of Permit No. 11G.

Photo 4. Ineffective sediment control (view northeast).

Remedial Action Required: Install adequate sediment control measures around the drop structure and the permit boundary to prevent sediment from leaving the permit area and plant the area with approved grass species.

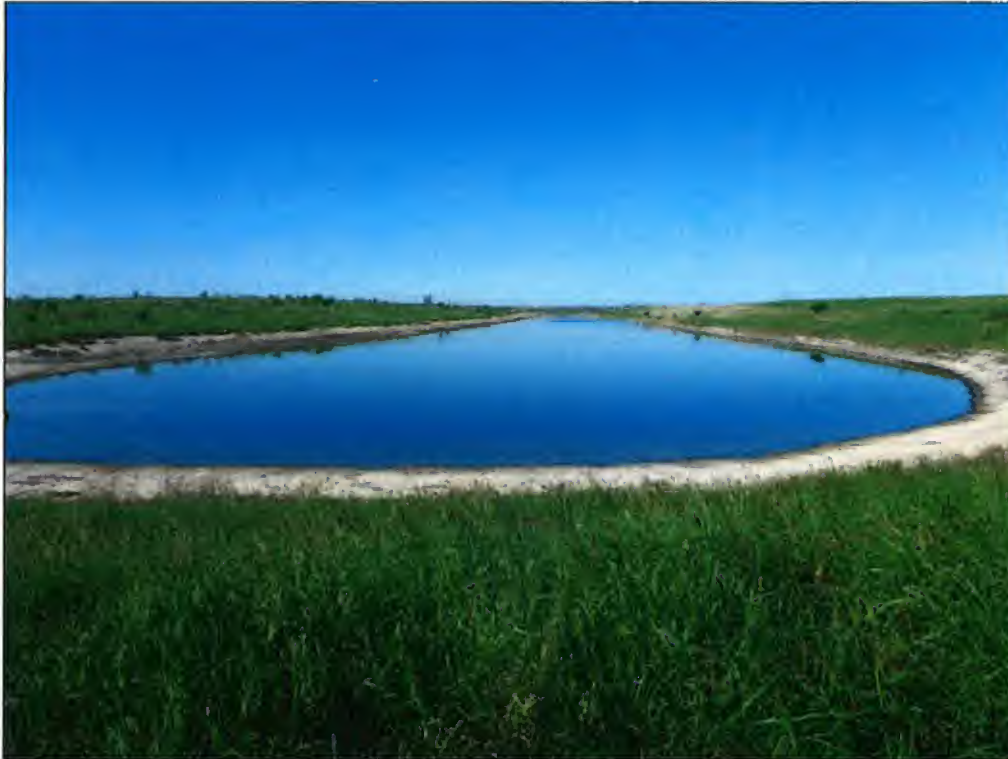
Photo 1. Vibrant vegetation around Pond 11 (view west).

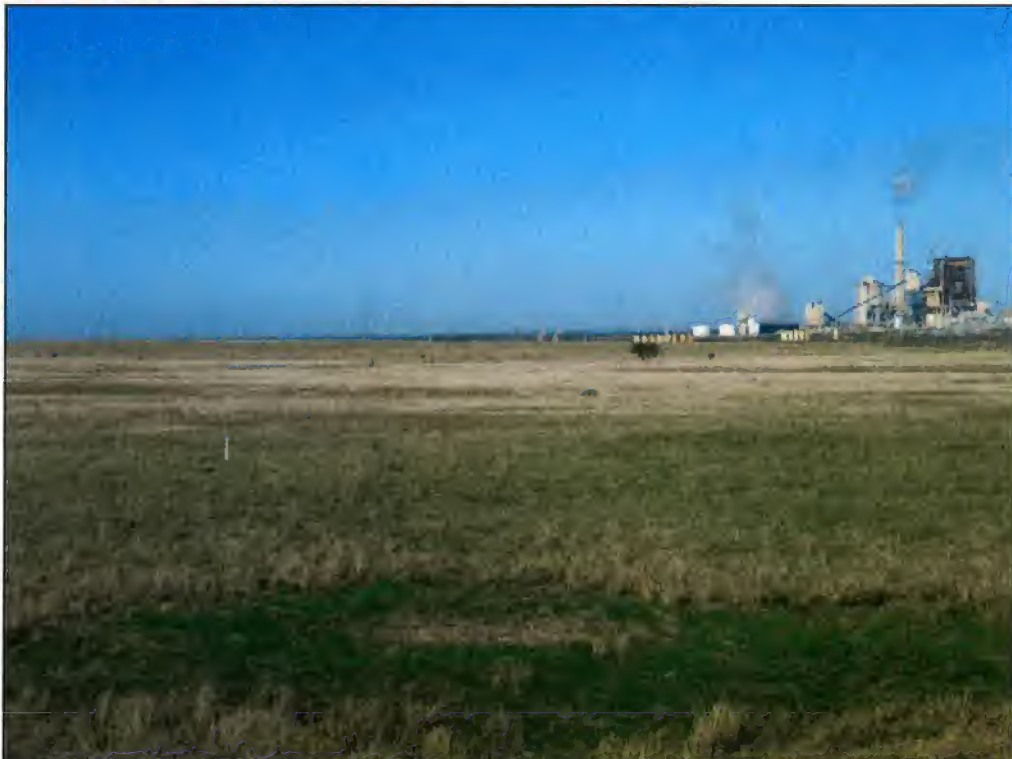
Photo 2. Vegetation west of Pond 1 (view northwest).

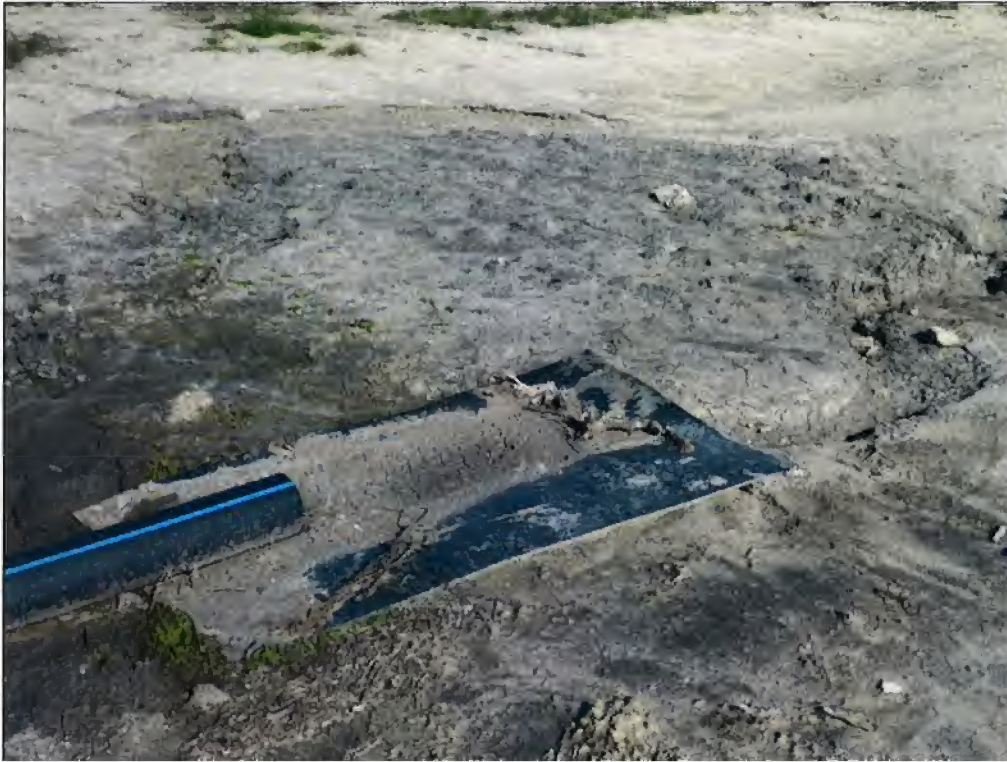
SMECI staff has corrected the minor erosion issue, noted in the September Inspection Report, concerning the discharge pipe located near the southeast corner of Pond 11. The area appeared to have been repaired and piece of conveyor belt was placed underneath the discharge pipe to prevent scouring of the soil when discharging (photo 3).

Photo 3. Conveyor material underneath the polypipe located south of Pond 11 (view northwest).

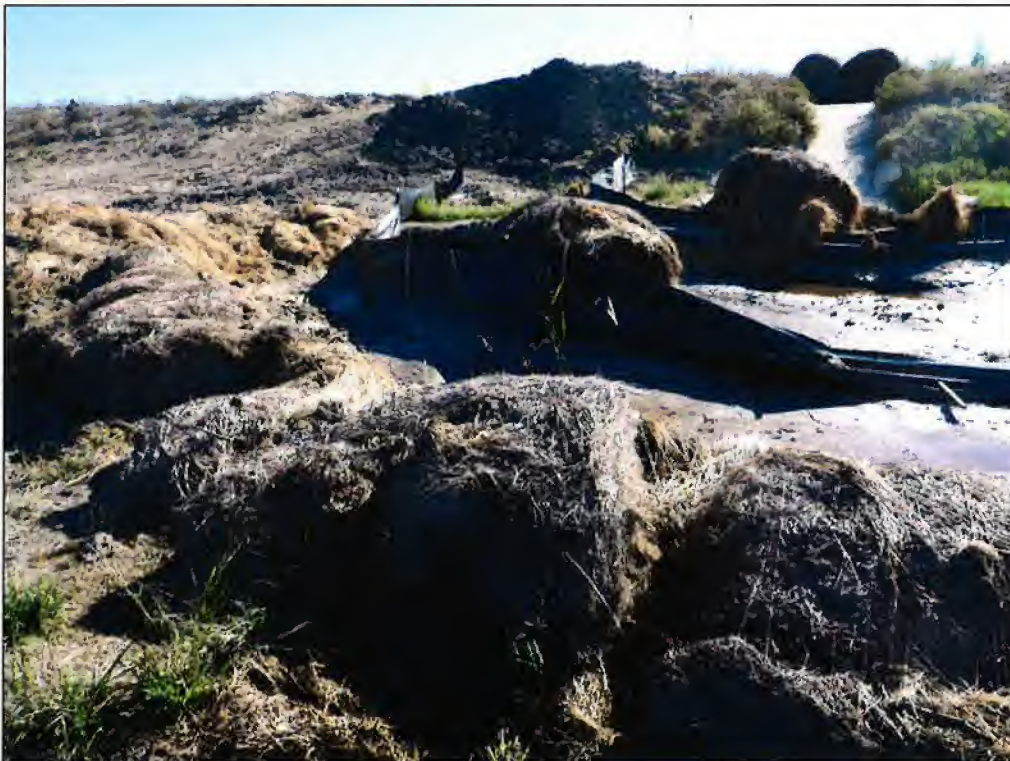
A significant breach in containment was observed at the BN-2 Drop Structure. After months of repeated warnings and recommendations from SMRD Inspector, Jacob Eickstead, the sediment control measures failed allowing sediment and water to flow freely out of the permit boundary and onto the adjacent landowner property (photos 4-7). Additional hay bales were placed at the top of the drop structure after the October inspection, but had since washed down to the bottom of the drop structure. In a phone conversation with SMECI representative, Dave Burris, I informed him that due to the lack of installing sufficient sediment controls and the disregard to SMRD inspector's warnings that a notice of violation would be issued for this area. Base material was brought in and staged at the Pond 10 Access Road entrance (photo 8). According to Mr. Burris, this material will be used to raise the haulroad and divert the runoff to the appropriate sediment ponds (Pond I and Pond J) and away from the BN-2 Drop Structure.

Photo 4. Sediment control failure at the BN-2 Drop Structure (view northeast).

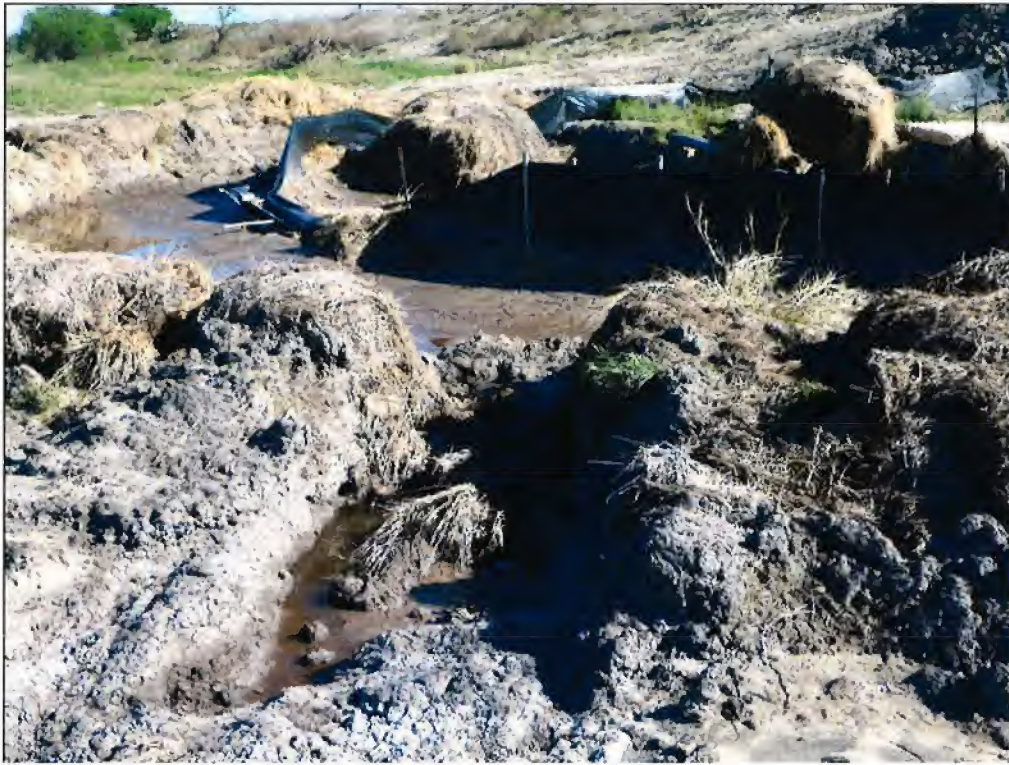
Photo 5. Hay bale and sediment eroded away (view northeast).

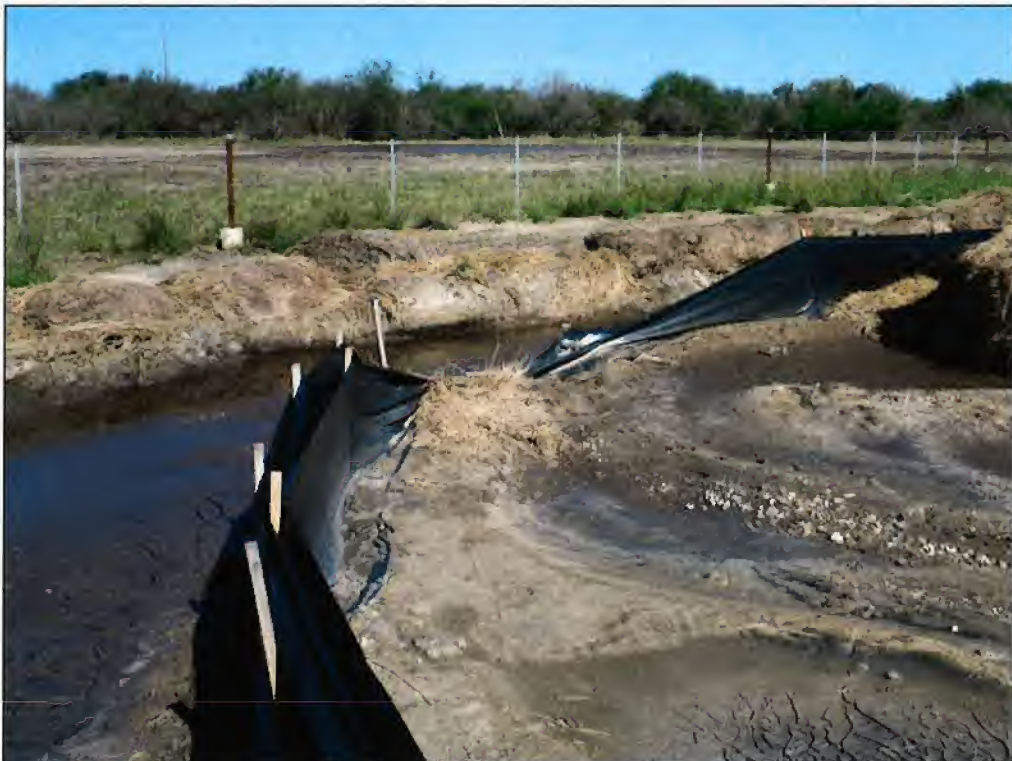
Photo 6. Overtopped silt fence (view north).

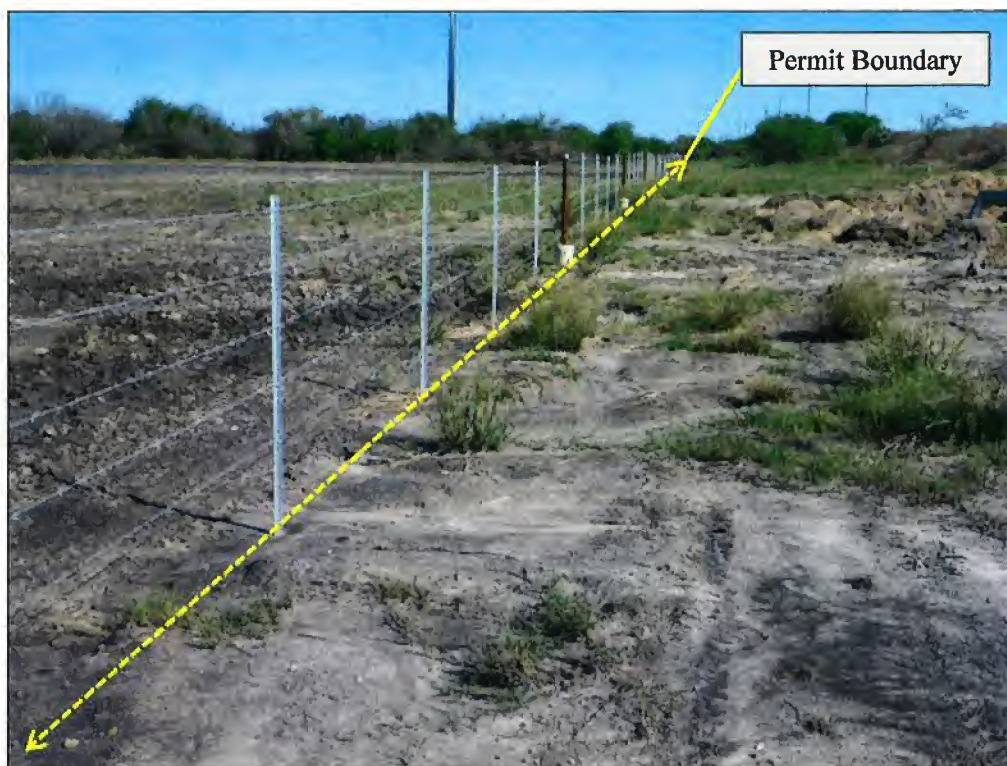
Photo 7. Lack of sediment control, sediment deposition offsite (view north).

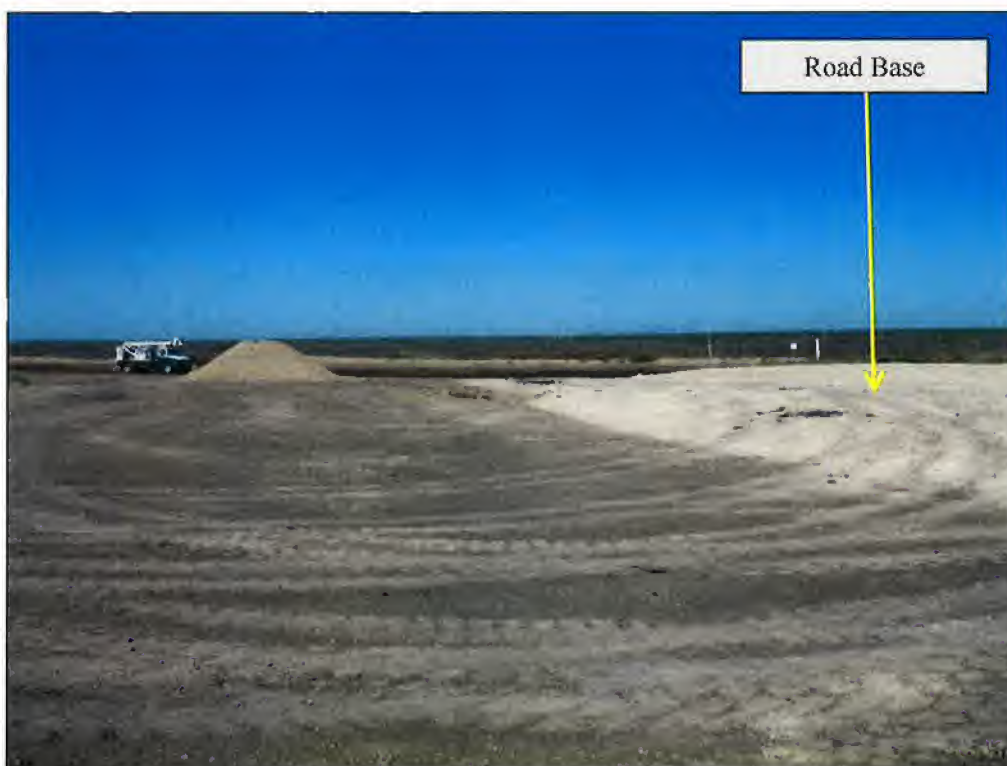
Photo 8. Road base material staged at the entrance to the Pond 10 Access Road (view west).

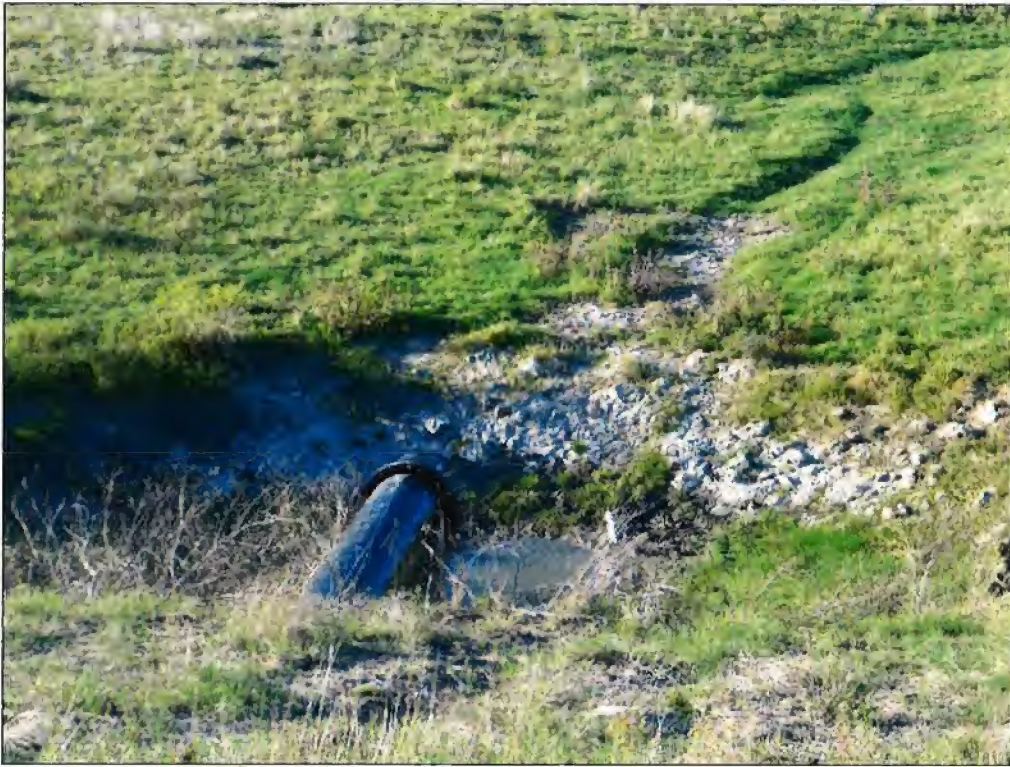
The ponds observed during the inspection appeared to be functioning as intended. No pond was observed discharging during the inspection. The Pond 15E discharge pipe (photo 9), Pond 1, Pond 8, and Pond A-1 were observed during the inspection (photos 10-12).

Photo 9. Pond 15E discharge pipe (view southwest).

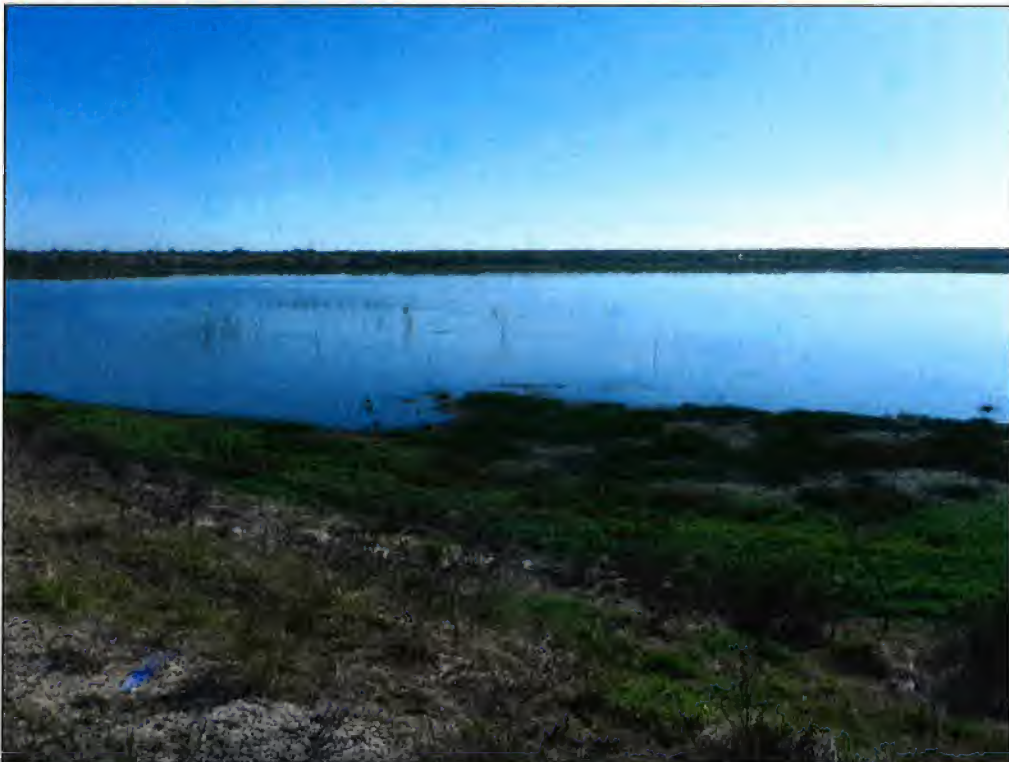
Photo 10. Pond 1 (view east).
